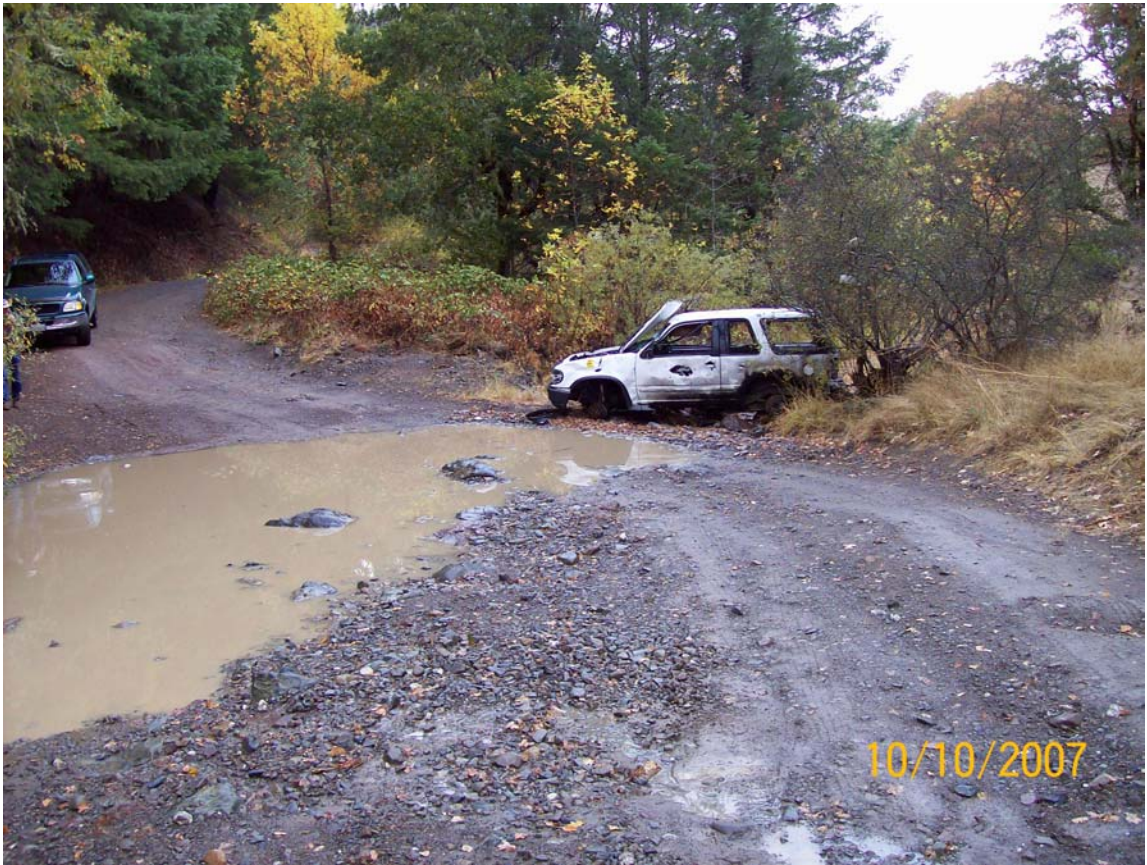
Photo 1. Abandoned car has been vandalized, burned and left in the creek at Crossing 2 where it remained for weeks. Turbid waters typical at crossings.

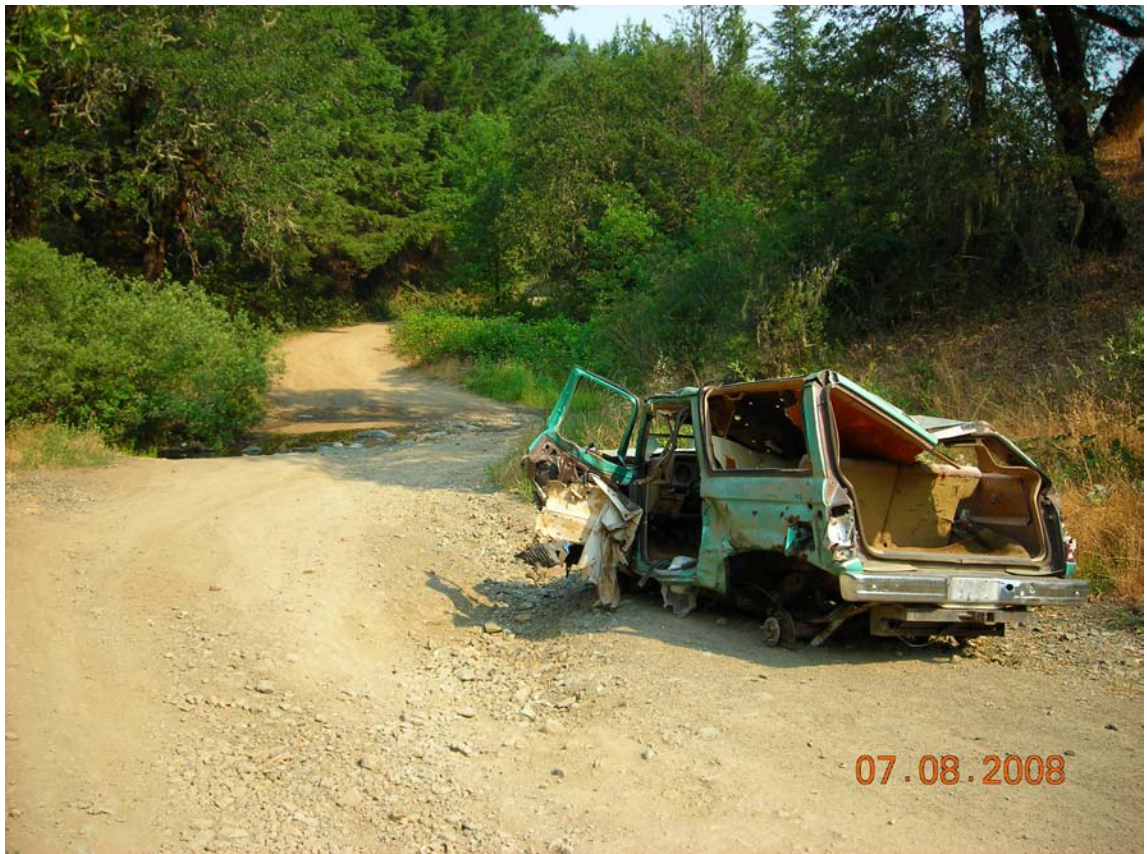
Photo 2. Another abandoned and vandalized vehicle just upstream of Crossing 2.

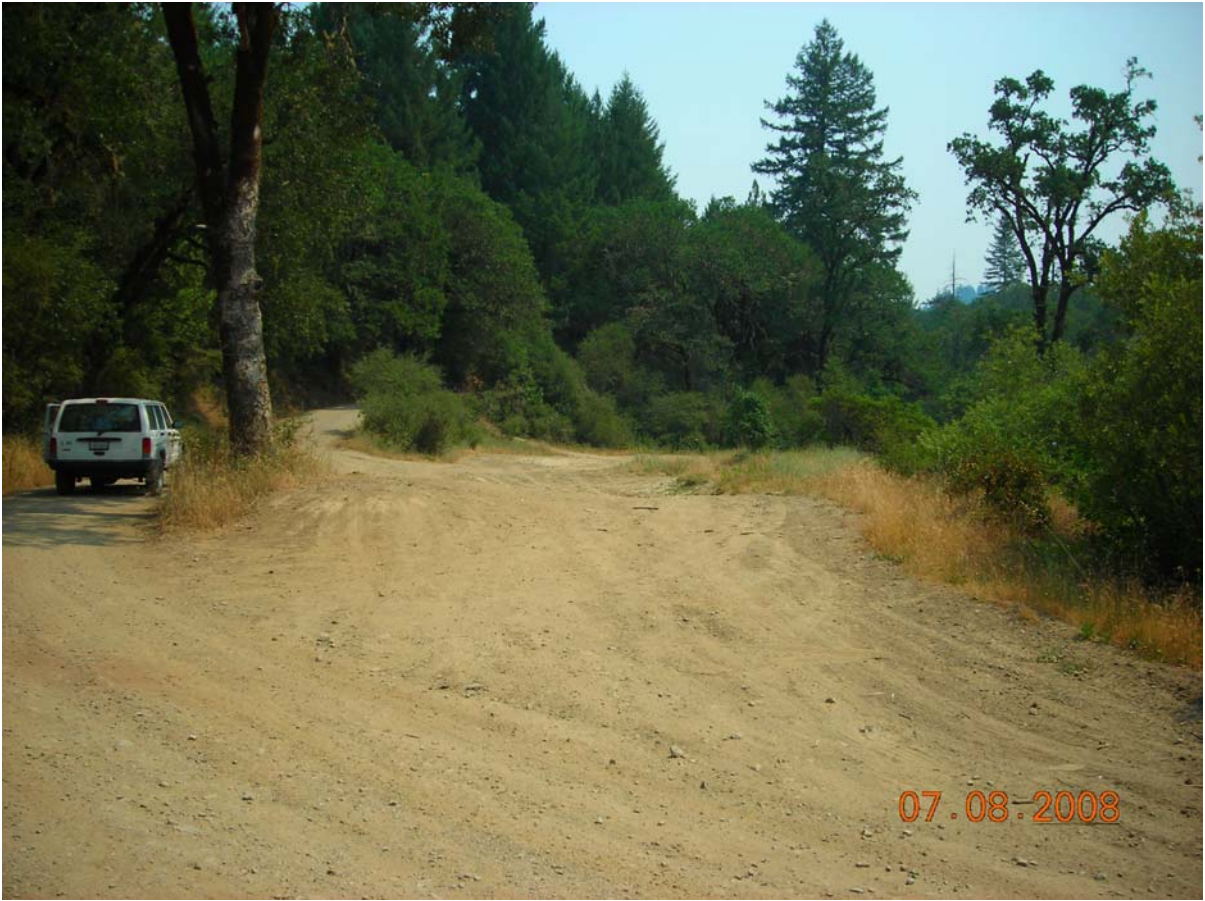
Photo 3. One of many off road vehicle areas delivering sediment to Cave Creek.

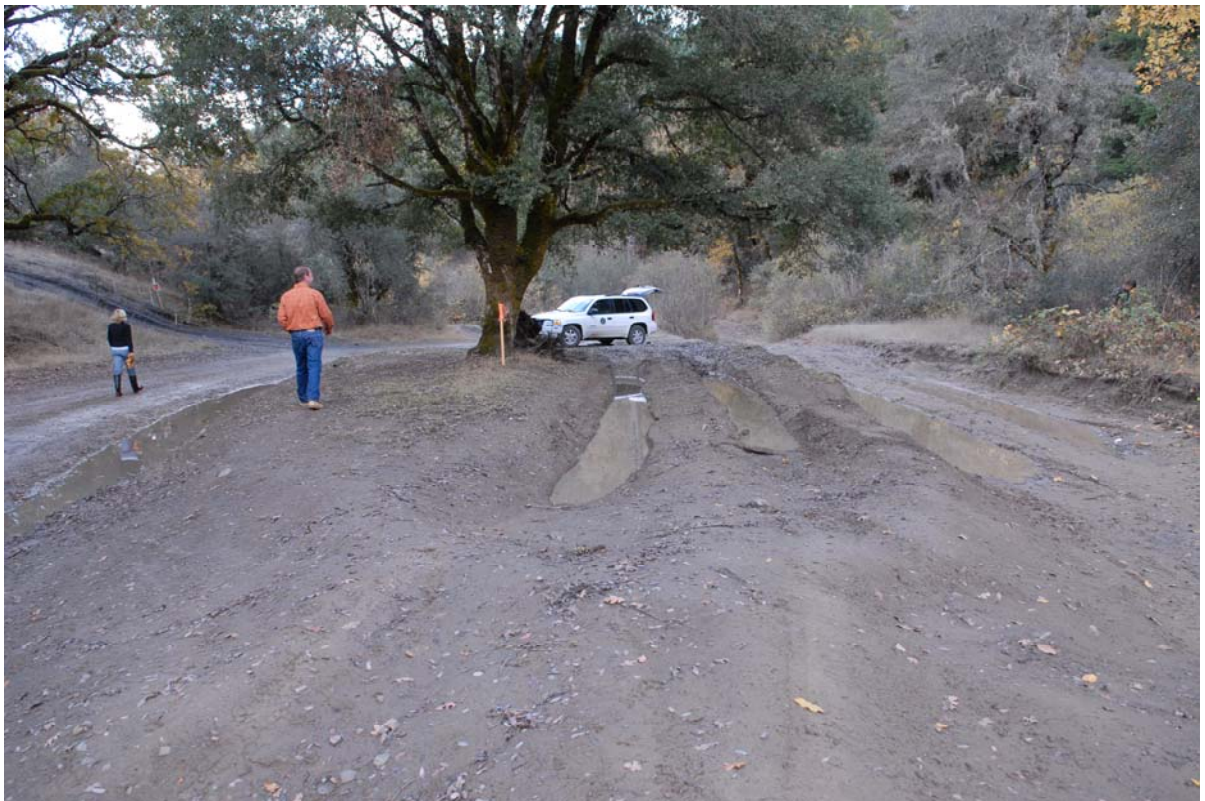
Photo 4. Severely degraded area adjacent to Cave Creek between Crossings 8 and 9. Ruts created by ORV activity.

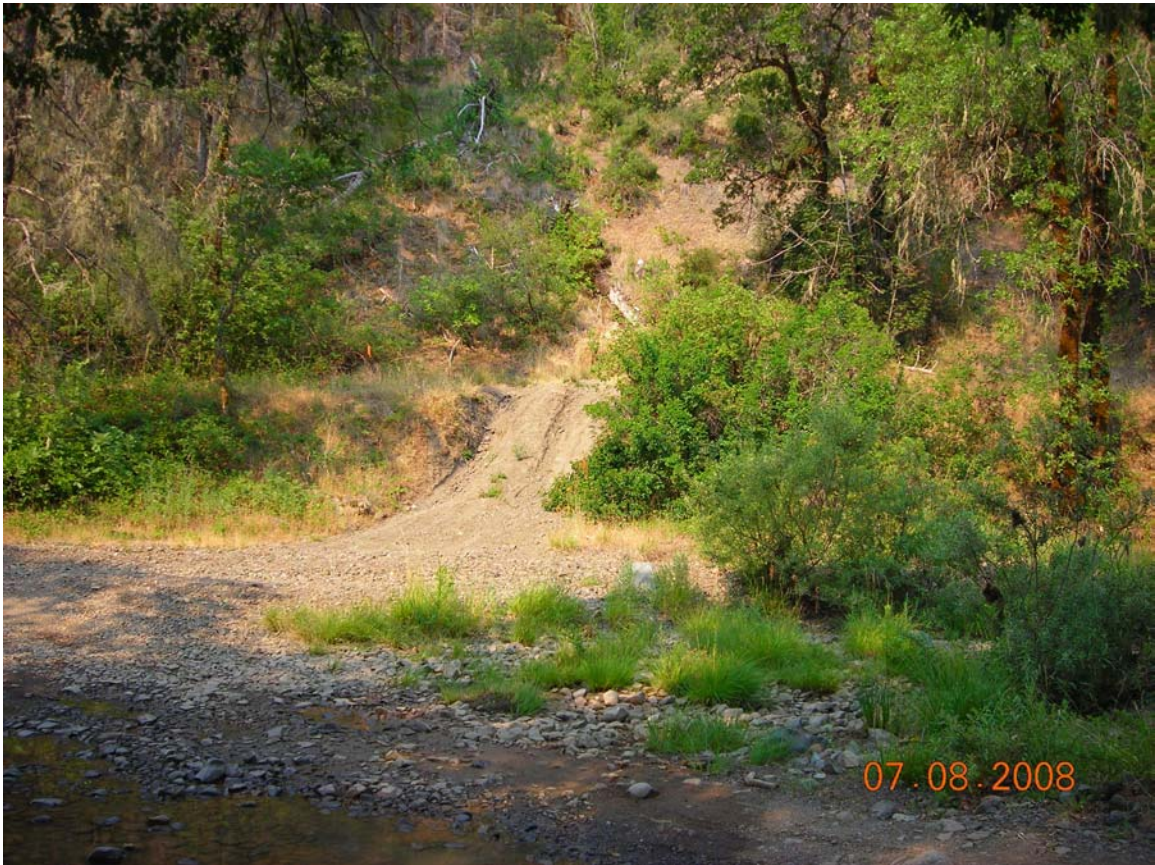
Photo 5. Many ORV trails lead directly to the creek bed.

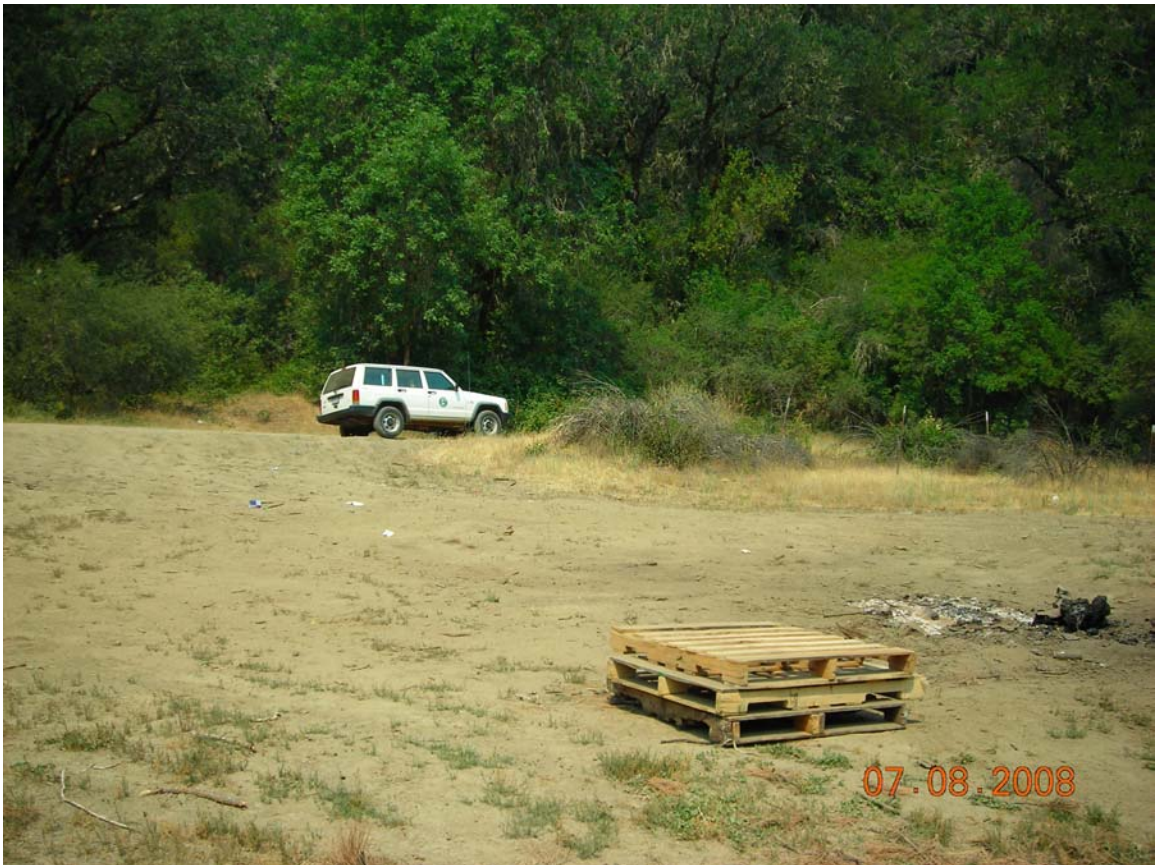
Photo 6. Popular off road area with bare, compacted soils littered with trash and remnants of a fire pit.

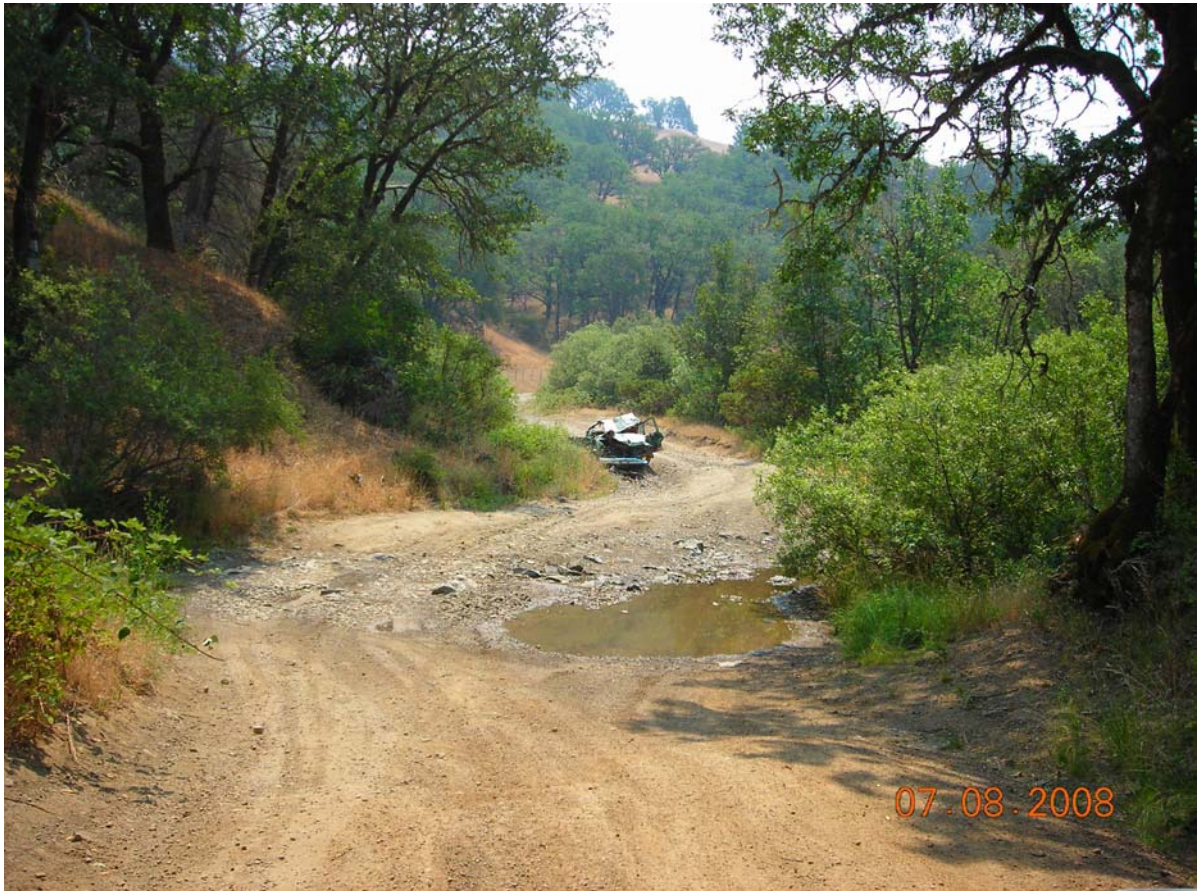
Photo 7. Common scene on Tomki Road (Crossing 2).

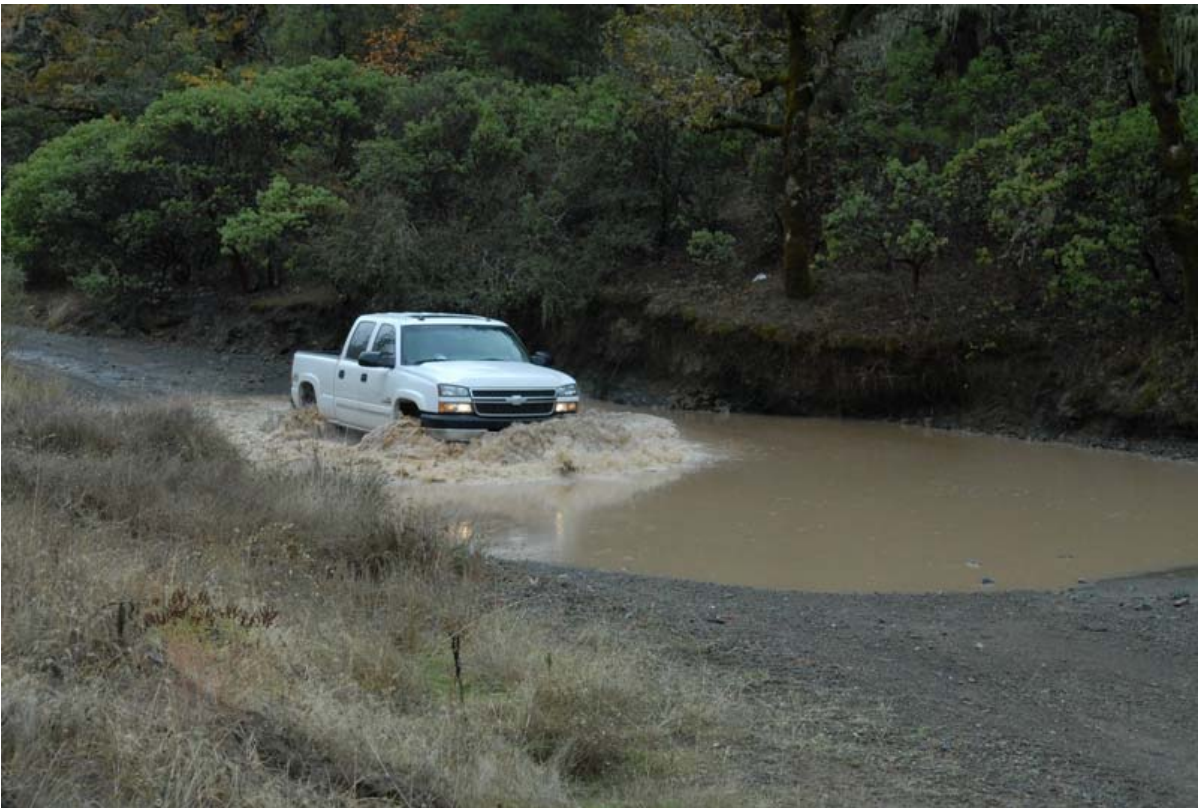
Photo 8. Hydrocarbons and other pollutants such as brake dust, oil and gasoline are easily delivered to stream waters from crossing vehicles.

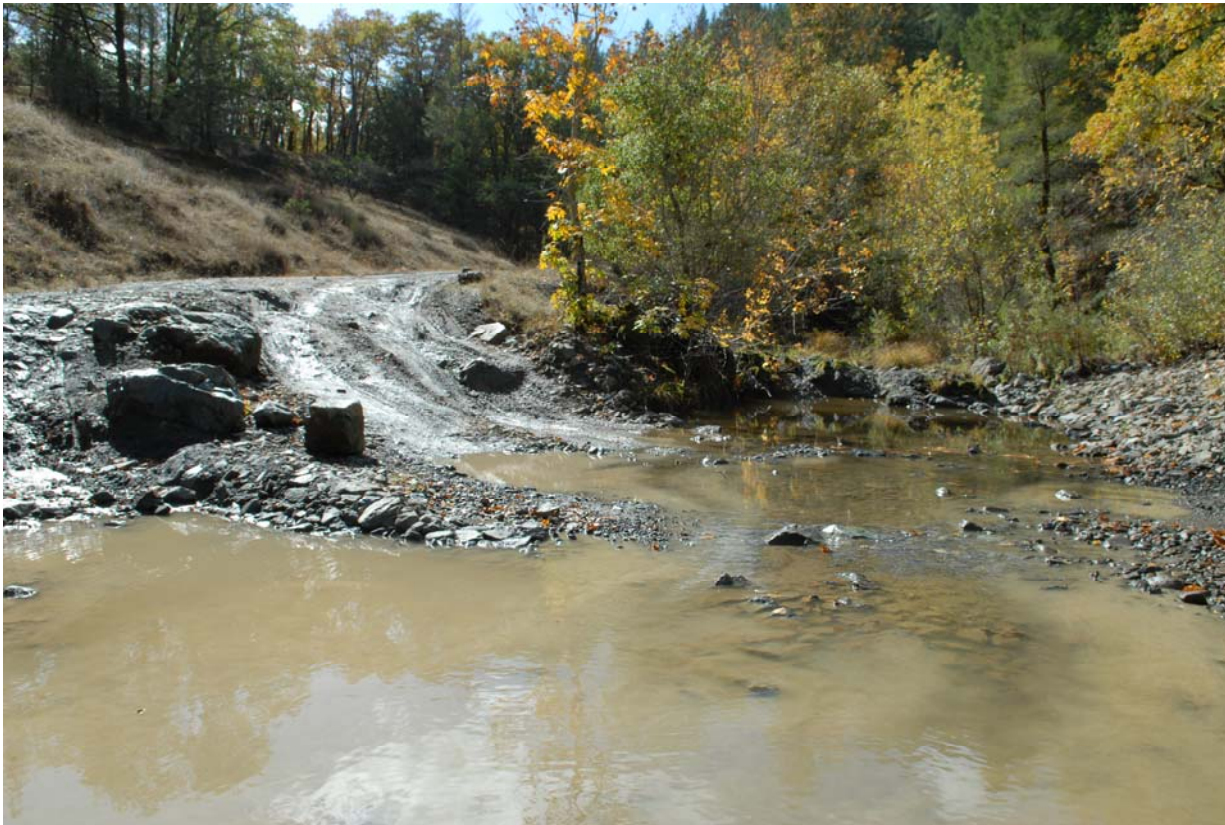
Photo 9. Steep, rocky, angled approach at Crossing 7.

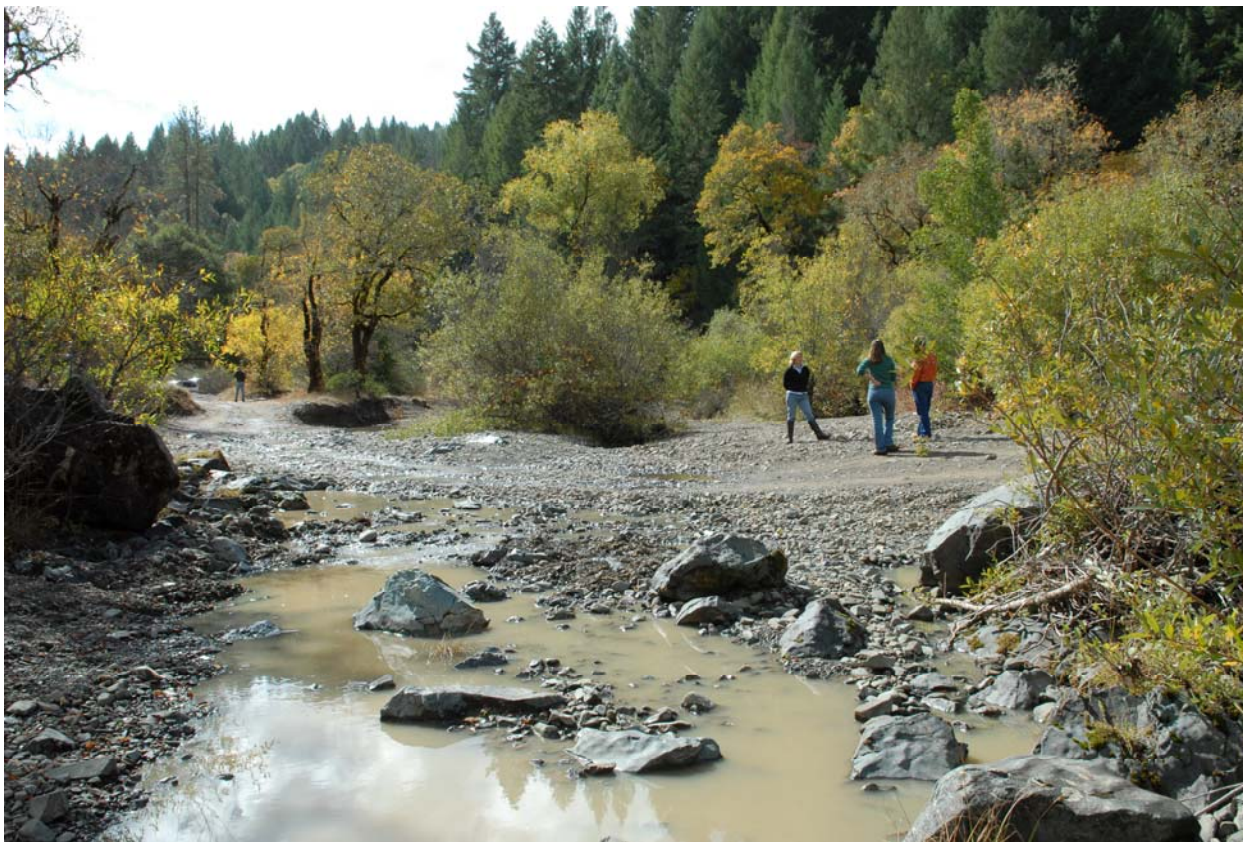
Photo 10. The widest ford, Crossing 9 is viewed from Cave Creek, looking upstream. The channel flows around the willow clump in the center; banks on both sides are actively eroding.
